Minerals Inspection Report

Mine Name: TM Crushing Elberta Pit	Permit Number: S/49/0092	Mine Status: Active
Operator Name: TM Crushing	Inspection Date: 9/7/2016	Permit Fees: Paid
Inspector(s): A.Abate	Inspection Time: 8:00 AM	Bond Amount: \$29,100
Attendee(s): Nick Baird, Operator	Weather: Clear 80s	Bond Escalation:
Inspection Purpose: Annual Inspection		Prior Inspection: 1/15/2016

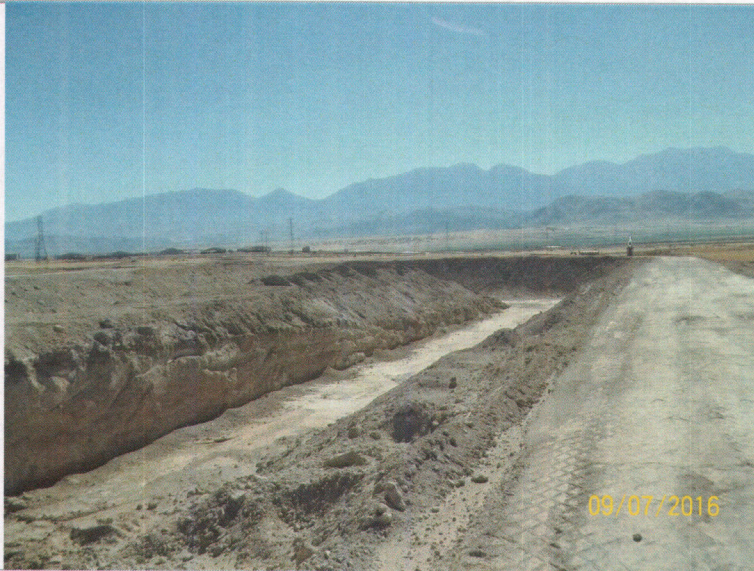
The berm along the west side of the east sediment pond needs to be built up.

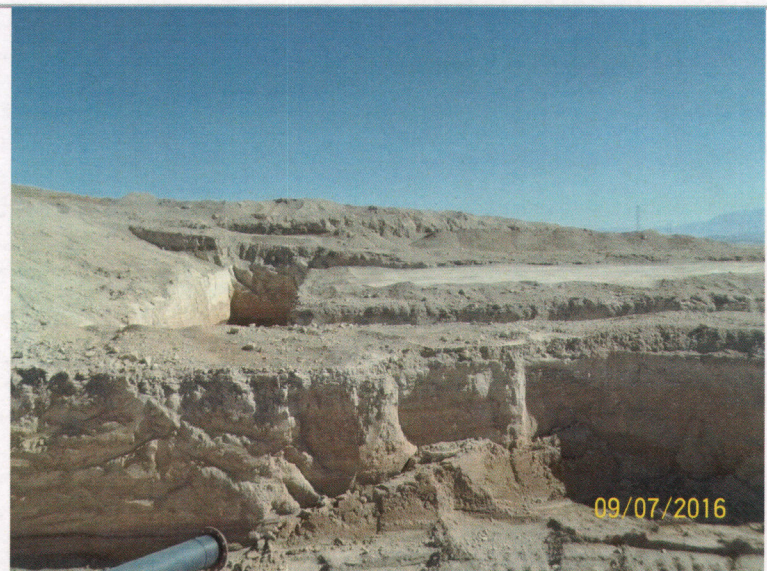
View of the west sediment pond looking west. Topsoil berm is shown towards the background.
